STEEL MAGNOLIA
Home Inspections

Home Inspection Report

Report Number: HI-062116-310

310 S Cypress Rd
Wilmington, North Carolina 28401

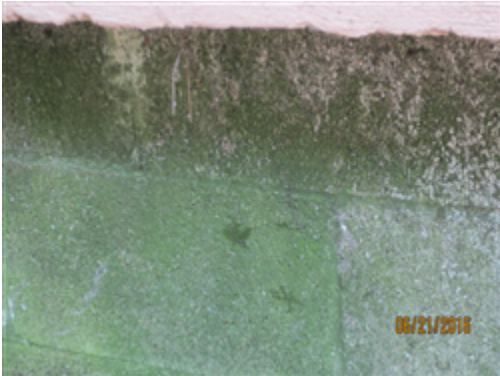
(A1 - 1.1) Porch left side

Stains and water lines indicate a history of standing water in the crawl space around the perimeter of the foundation and under the porches. Direct water penetration damages the foundation, the wood structure, and creates an undesirable environment in the crawl space areas that encourages insect, fungal growth such as mold/mildew. Repairs are needed to prevent water penetration. Water in the crawl space indicates an absent or damaged waterproofing and foundation drain system. Repairs are needed to prevent water penetration. A general contractor should be consulted for further evaluation to determine the source of the moisture and to make necessary repairs.

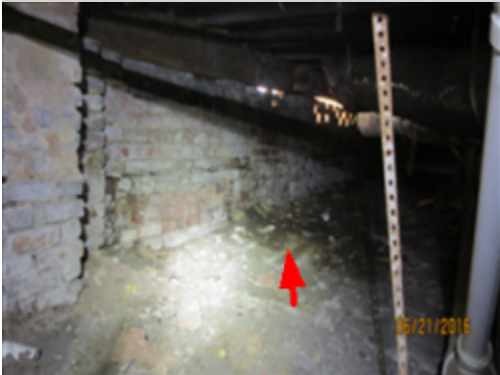
(A1 - 2.1) Main House

Stains and water lines indicate a history of standing water in the crawl space around the perimeter of the foundation and under the porches. Direct water penetration damages the foundation, the wood structure, and creates an undesirable environment in the crawl space areas that encourages insect, fungal growth such as mold/mildew. Repairs are needed to prevent water penetration. Water in the crawl space indicates an absent or damaged waterproofing and foundation drain system. Repairs are needed to prevent water penetration. A general contractor should be consulted for further evaluation to determine the source of the moisture and to make necessary repairs.

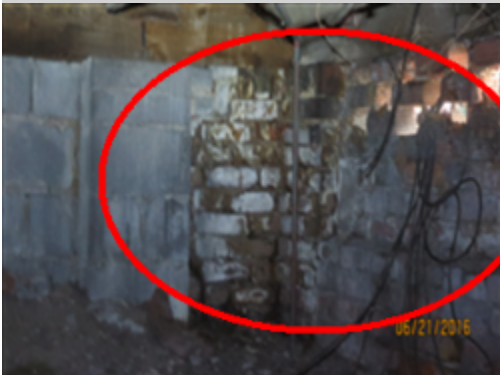
(A1 - 2.2) Main House

Efflorescence (salt stains) was noted on the foundation walls. The stains indicate that the foundation was been cyclically wet and dry. Water penetration into the foundation area can result in structural damage and undesirable environmental conditions. Water in the foundation area indicates an absent or damaged waterproofing and foundation drain systems. Repairs are needed to prevent water penetration. A general contractor should be consulted for further evaluation to determine the source of the moisture and to make necessary repairs.

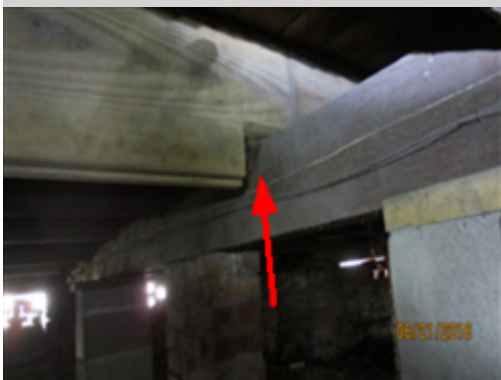
(A3 - 1.1) Main House

The floor joist located in the crawl space close to front of the home has been notched at the end. The notch is larger than what would be typically expected and could result in cracking or failure of the joist. A licensed general contractor should be consulted for further evaluation and to make necessary repairs.

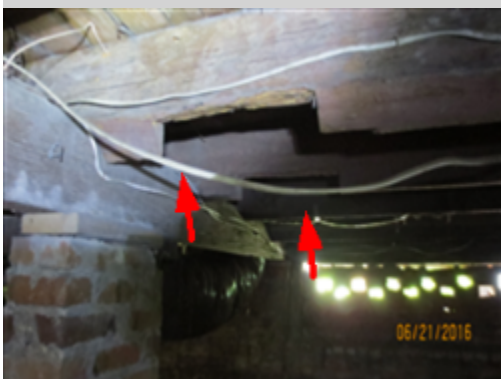
(A3 - 1.2) Main House

The floor joist located in the crawl space close to the front of the home has been notched. The notch is larger than what would be typically expected and could result in cracking or failure of the joist. A licensed general contractor should be consulted for further evaluation and to make necessary repairs.

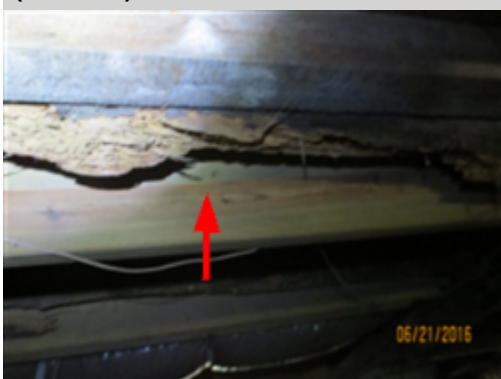
(A3 - 1.3) Main House

A licensed pest inspector should also be consulted to determine activity level for the insects and if treatment is required.

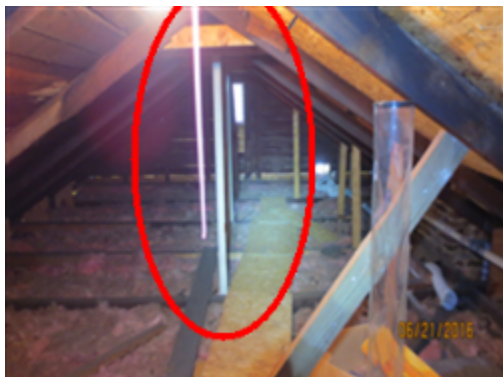
(A6 - 1.1) Main House/ Attic

A general contractor should be consulted for further evaluation and to make necessary repairs. The roof framing has been modified, the area of concern was located in the left side of attic. The framing modifications do not follow standard framing methods that would normal be observed for a framing repair. The owners should be asked for disclosure related to the extent and history of repairs and if all required building permits were obtained. A licensed general contractor should be consulted for complete evaluation of the roof system to determine the extent of the concern and to make necessary repairs to ensure the stability and durability of the roof system.

A general contractor should be consulted for further evaluation and to make necessary repairs. The roof framing has been modified, the area of concern was located in the left side of attic. The framing modifications do not follow standard framing methods that would normally be observed for a framing repair. The owners should be asked for disclosure related to the extent and history of repairs and if all required building permits were obtained. A licensed general contractor should be consulted for complete evaluation of the roof system to determine the extent of the concern and to make necessary repairs to ensure the stability and durability of the roof system.

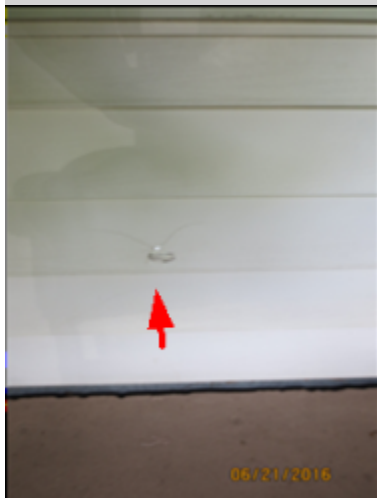
(B1 - 1.1) Main House Right

The siding for this home is a vinyl material. The siding on this home has visible areas of damage, cracking, mismatched colors, loose pieces, and fading. A licensed general contractor should be consulted for complete evaluation to locate and repair all areas of damage.

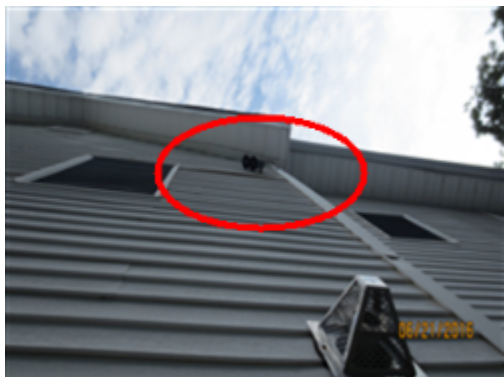
(B1 - 1.2) Main House Right

The siding for this home is a vinyl material. The siding on this home has visible areas of damage, cracking, mismatched colors, loose pieces, and fading. A licensed general contractor should be consulted for complete evaluation to locate and repair all areas of damage.

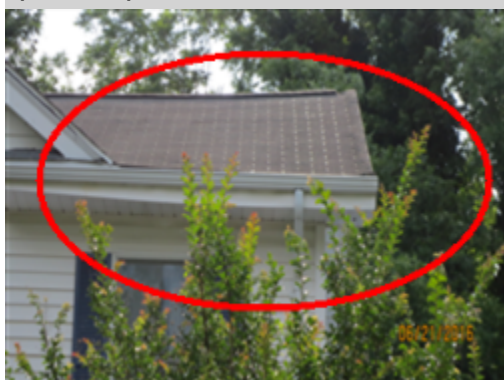
(C1 - 1.1) Main House

The roof covering system is in need of further evaluation and repair. The following concerns were noted at the time of the inspection: sagging noticed on front right of main roof A licensed roofing contractor should be consulted for a complete evaluation of the roof covering and flashings system to make necessary repairs to ensure the weather-tightness of the roof covering system. At the time of the repair, the roofer may be able to answer questions related to the life expectancy of the roof covering system.

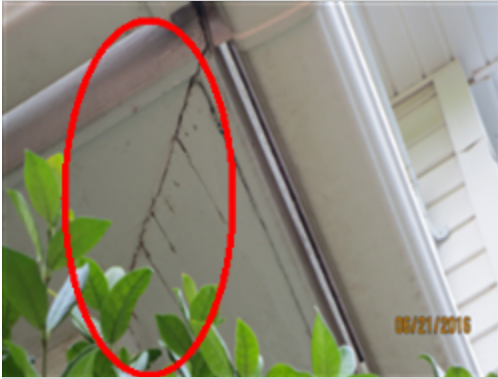
(C2 - 1.1) Main House

The roof gutters were found to be in poor condition and in need of repair /replacement. Evidence of roof drainage overflow in the boxing areas and behind the siding has resulted in visible areas of damage. Invasive inspection of boxing and adjacent siding areas is needed when gutters are repaired/ replaced. A licensed general contractor should be consulted for a complete inspection to determine the significance of the concern and to make necessary repairs.

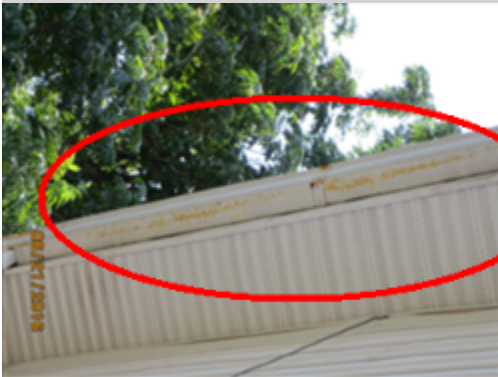
(C2 - 1.2) Main House

Additional Photograph: This is a photograph of rust on bottom, underside of gutter on the left side of main house near the back.

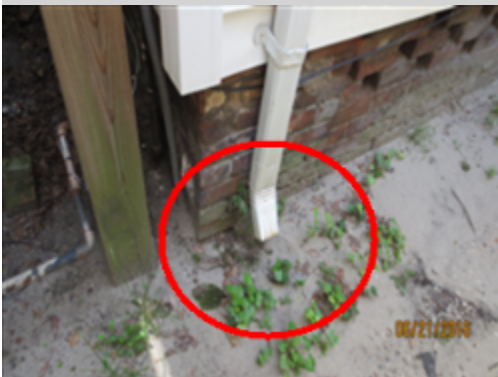
(C2 - 1.3) Main House

Additional Photograph: This is a photograph of down spout draining at foundation.

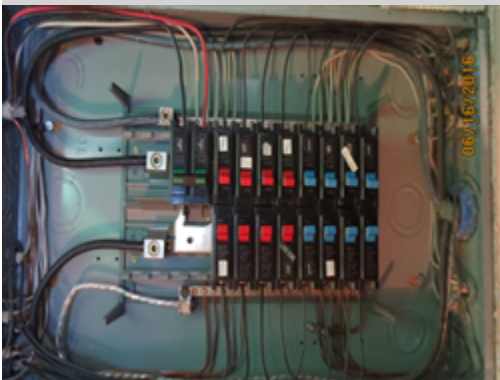
(E2 - 1.1) Main Panel #1

The electrical system of this home does not have a safe and effective way to quickly turn the power off in case of an emergency. Typically any system that requires more than six hand movements to shut down all system is considered unsafe. A licensed electrical contractor should be consulted for repair and a complete evaluation of the electrical system.

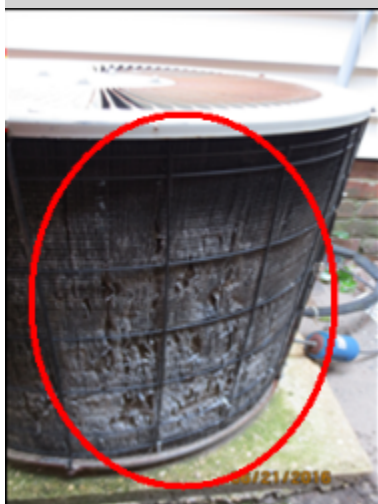
(F1 - 1.1) Heating Unit #1

The outside compressor/coil unit for the heat pump system has visible damage to the coil fins. A damaged coil can result in leaking refrigerant and poor system performance. A HVAC contractor should be consulted for a complete evaluation and to make necessary repairs to ensure safe, reliable, and proper operation of the HVAC system.

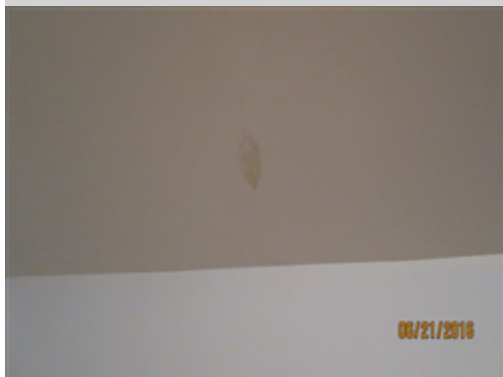
(H1 - 1.1) Living Room

Stains on the ceiling in the main living room above front window indicate a history of a leak. At the time of the inspection it was not possible to determine if the condition was due to an active or past occurrence. Further investigation by a repair specialist and owner disclosure is recommended.

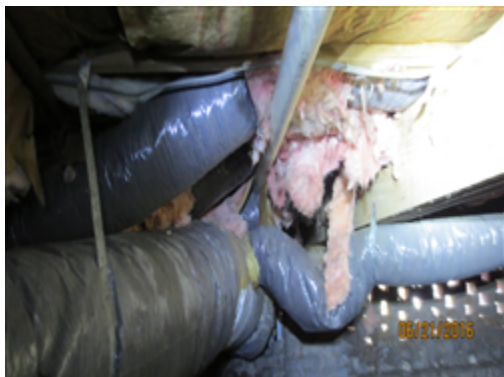
(I1 - 1.1) Crawl Space: Main House

The insulation is/has been wet due to leaks or elevated area moisture levels. Typically insulation must be replaced if it has been because it does not retain fire protective coatings. The insulation needs to be replaced and the adjacent areas inspected for damage. See other sections for further information. A licensed general contractor should be consulted for repair/ replacement.

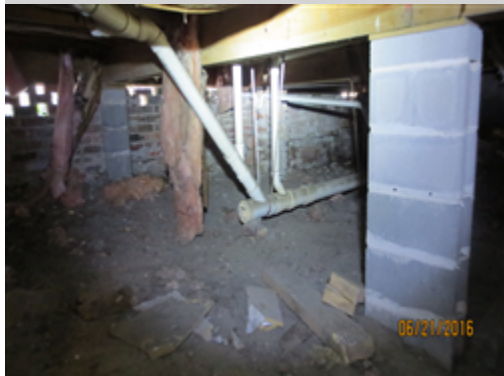
(I1 - 1.2) Crawl Space: Main House

Additional Photograph: This is a photograph of wet insulation in crawlspace.

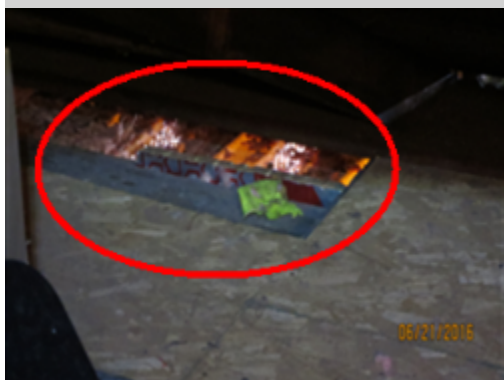
(I1 - 2.1) Attic: Main House

The soffit vents are covered or blocked. Improper ventilation could result in condensation, over heating of the building components, over heating of the building components, and inadequate conditioning of the living areas. A licensed general contractor should be consulted for repair/ replacement.

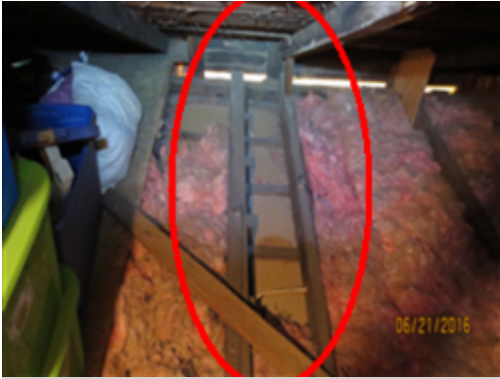
(I1 - 2.2) Attic: Main House

A section of insulation in the attic/ crawl space is missing. Improper insulation installation could result in condensation, over heating of the building components, and inadequate conditioning of the living areas. A licensed general contractor should be consulted for repair/ replacement.

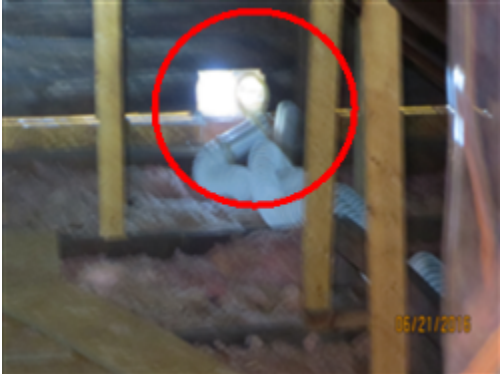
(I1 - 2.3) Attic: Main House

The bathroom ventilation fan exhaust duct does not exit to the exterior of the home. The fan exits to the attic space which will add undesirable moisture to the area. A licensed general contractor should be consulted for repair/ replacement.
